Manhole Inspection Summary

Manhole # S29Q__019MH

Insp Date: **11/26/08 7:41 AM**

Location Address: **1267 W Ostend St**

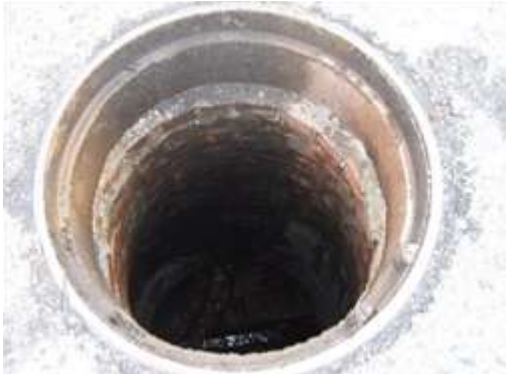
Defect

Offset: **1.5** (in.)

1.5 inches offset

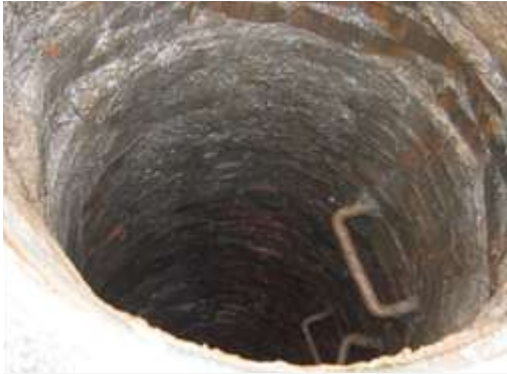
Defect 2

Condition: ☐ Sound ☐ Cracked ☒ **Leaks**

infiltration frame/lid

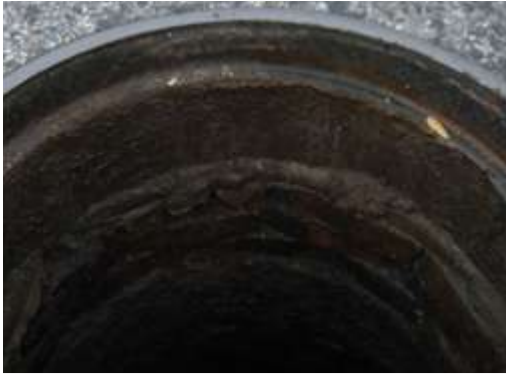
Defect 1

infiltration lid/frame

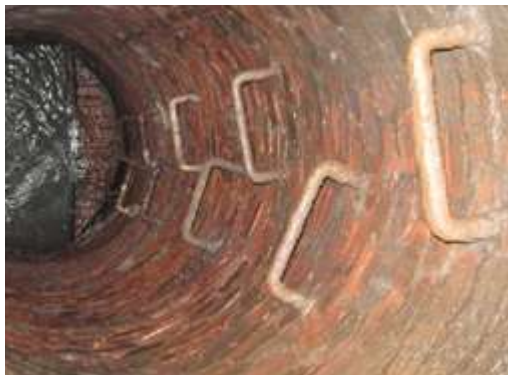
Defect

Count: **8** Missing: **0** ☒ **Corroded**

oxidized some corrosion rungs

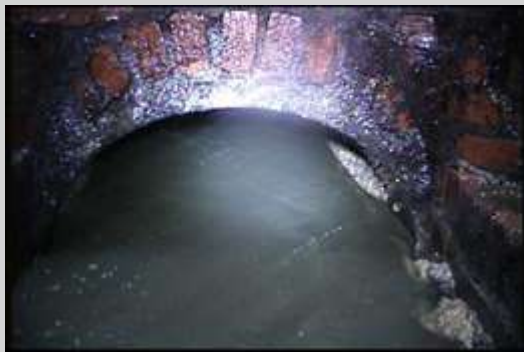
12 O'Clock Outflow

Pipe Height: **24** (in.) Rod and Bar (Angled)
Pipe Material: **Clay** ☐ Pipe Lined
Invert Depth: **16.90** (ft.) Flow Characteristics: **Fast**
Deposits: ☐ None ☐ Mud ☐ Sludge ☒ **Debris** ☐ Grease
Silt Depth: **8** (in.) Deposits Extent: **Heavy**
Infiltration: **None** Pipe Seal Cond: **Sound**

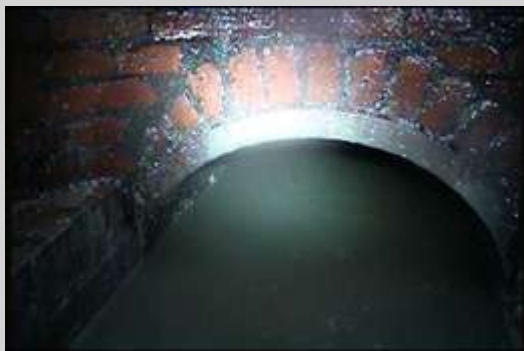
6 O'Clock Inflow

Pipe Height: **24** (in.) Rod and Bar (Angled)
Pipe Material: **Clay** ☐ Pipe Lined
Invert Depth: **16.86** (ft.) Flow Characteristics: **Fast**
Deposits: ☐ None ☐ Mud ☒ **Sludge** ☐ Debris ☐ Grease
Silt Depth: **8** (in.) Deposits Extent: **Heavy**
Infiltration: **None** Pipe Seal Cond: **Sound**
